# REFURBISHED EXTERIOR PROVIDES NEW LOOK AND ADDED LIFE TO ARLINGTON APARTMENTS

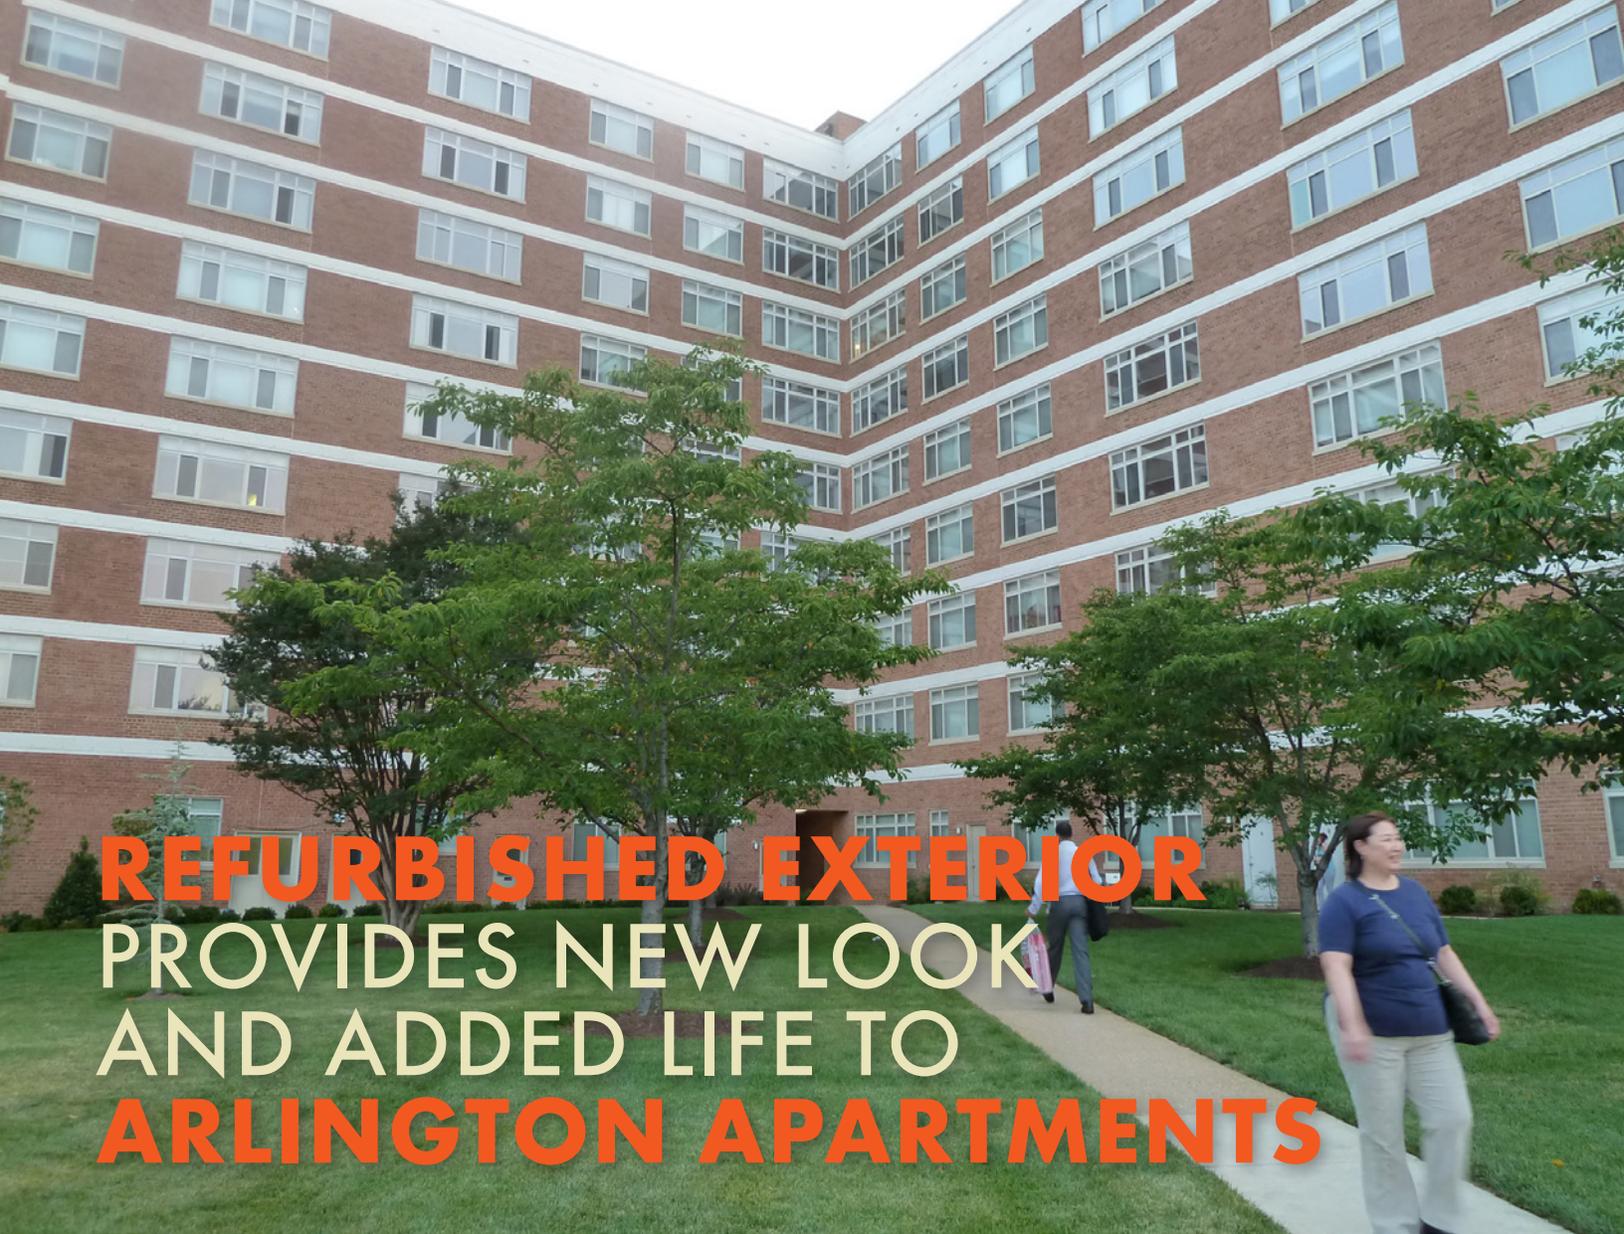
*The completed work shown here at the rear entrance of the building is one of the four V-shaped quadrants created by the X-shaped building.*

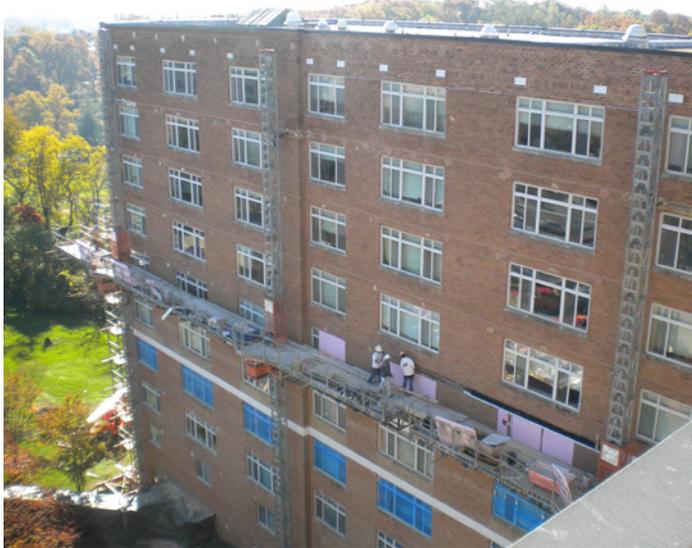
common bond without relieving angles to help carry their weight; as a result the façade was beginning to crack and sag from years of stress under expansion and contraction. But a complete removal of the exterior would mean disrupting the more than 330 individuals and families who live there.

**The repair work involved removing 16-inch-high bands of brick to reveal the eight-inch floor slab.**

JBG worked with Fox Architects and Kramer Consulting (structural engineers) to develop a restoration plan for Dominion Towers. They chose Manganaro Midatlantic, LLC, to perform the work, which required removal of 16-inch-high bands of brick (five-courses) at each level of the building to reveal the eight-inch floor slab. The contractor's crews would install relieving angles at each floor to help support the brick, and then insert a through-the-wall flashing system along the relieving angles to keep water out of the face of the building. The final step in the process would be the replacement of the five rows

of original red brick with a contrasting white brick that defines the building's exterior with a new architectural presentation.

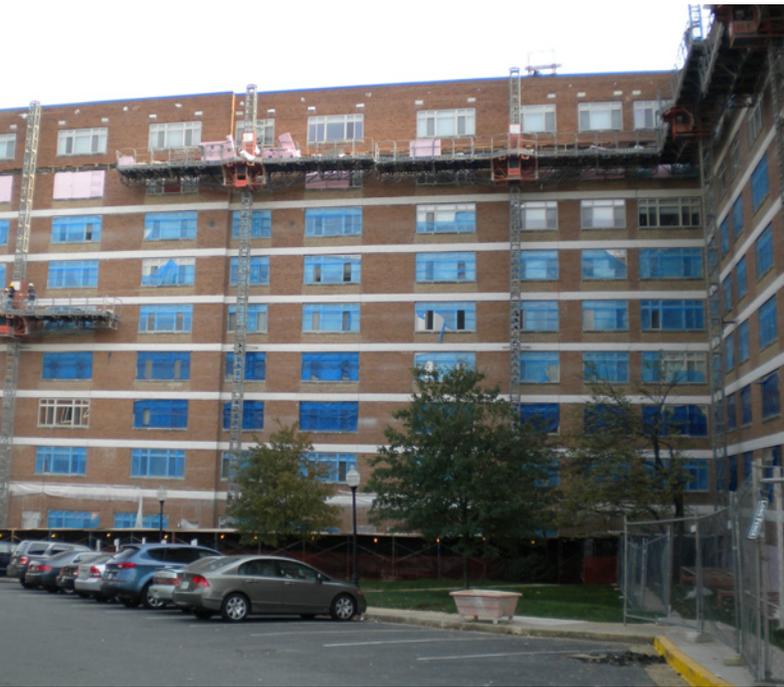
***Manganaro Midatlantic, LLC, took care to protect the building and residents during the work by covering all of the windows in the complex with protective film, covering windows on the floor it was working on with rigid insulation, and installing overhead protection across walkways.***
